DOT/FAA/AR-04/26

Flammability Assessment of Bulk-Packed, Nonrechargeable Lithium Primary Batteries in Transport Category Aircraft

Final Report

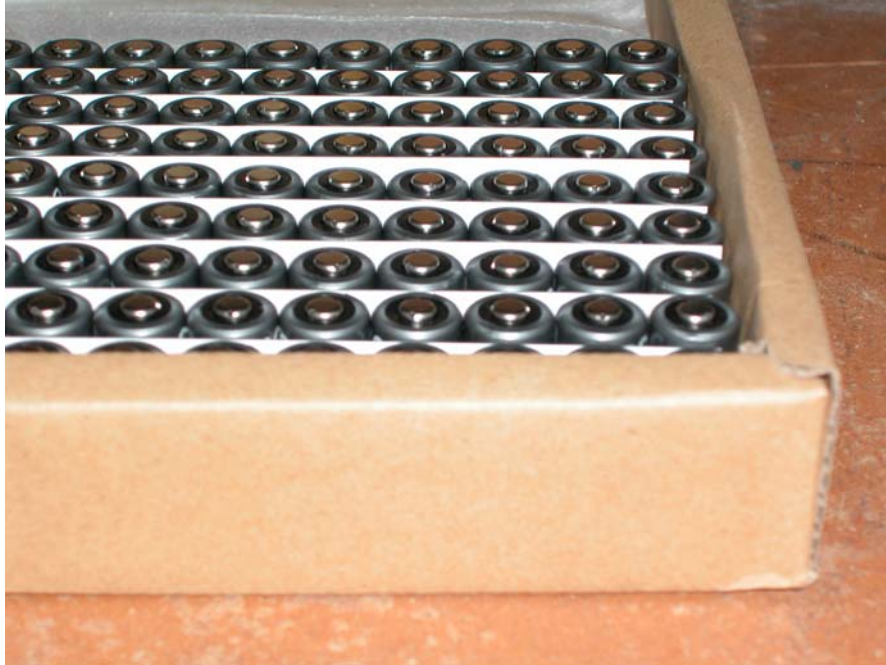
A series of tests were conducted to determine the effect of the packaging materials on the ignition and propagation of CR2 batteries when exposed to a 1-propanol fire. The tests used corrugated cardboard cases, smooth cardboard separators, and polyurethane foam cushions from actual CR2 shipping boxes, as shown in figure 6. The batteries and shipping materials were suspended 3" above the fire pan. Tests were conducted using 32, 64, and 128 CR2 batteries. The tests using 32 and 64 batteries used the 5.25" fire pan and 50 ml of 1-propanol. The test using 128 batteries used the 10.75" fire pan and 220 ml of 1-propanol. The 10.75" fire pan allowed for better flame exposure to the test carton.

FIGURE 6. SANYO CR2 BATTERIES PACKED IN A STANDARD BULK SHIPPING CONTAINER

The packing material had several noticeable effects on the battery flammability compared to the multiple-battery tests conducted without packing material. The packing material is quite flammable, igniting easily when exposed to the 1-propanol fire. The packing material fire was sufficiently intense to ignite the CR2 batteries. It does, however, delay the ignition of the batteries by 30 to 60 seconds. In addition, the packing material kept the batteries in close proximity to one another, allowing the heat of the fire to fuse them together. This fusing facilitated the fire propagation between batteries once a single battery was ignited.

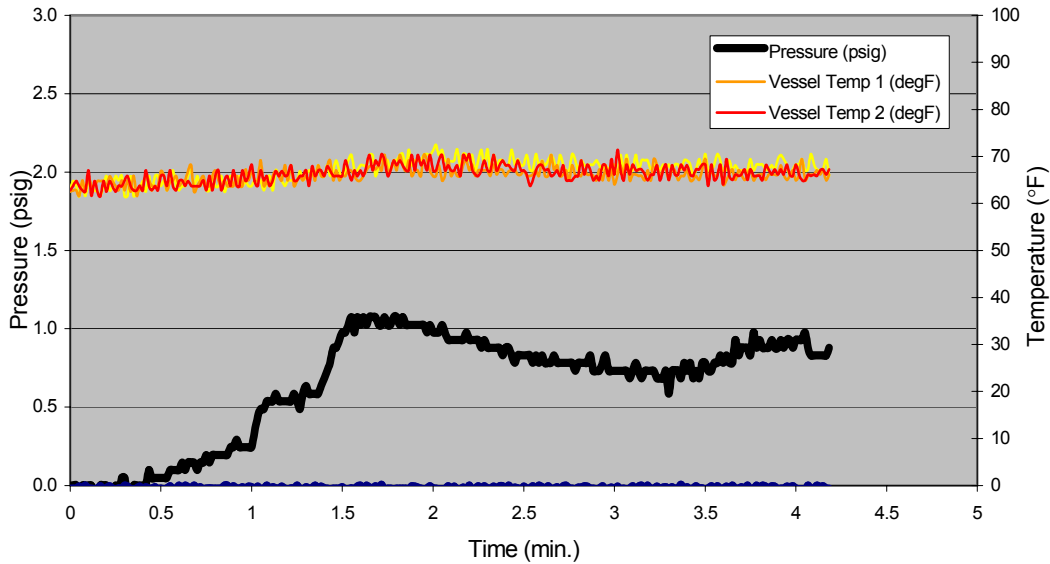
additive fashion: the pressure from each battery added to the total vessel pressure with no loss due to leakage. The four-battery test raised the pressure by approximately 1.1 psi (see figure 13). The eight-battery test raised the pressure in the vessel by 1.8 psi (see figure 14). The 16-battery test raised the pressure by 2.6 psi (see figure 15). In each test, the temperature in the vessel only increased a few degrees Fahrenheit, contributing little to the overall pressure rise.

FIGURE 13. SANYO CR2 FOUR-BATTERY EXPLOSION TEST
